# Lens Condition Analysis

## Exploring lens failures and their causes

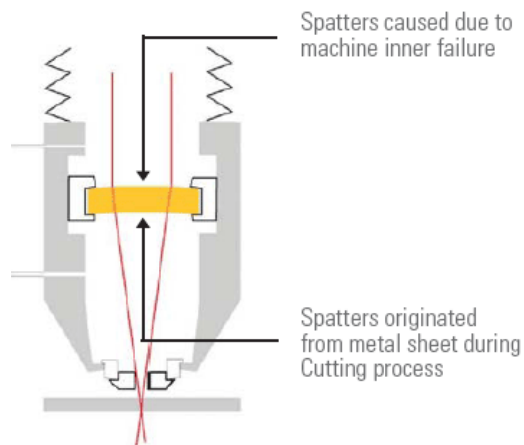
**A. Upper side (CX)** - normally caused by contamination originating from the machine side. Common types of contaminations include:

- Unsealed Beam Delivery system (holes in the bellows). This allows small particles to get into the Beam Delivery system, where they can land on top of the lens and cause uneven heat distribution.
- Oil/liquid contamination due to blocked filters, air separator etc.

Fig. 1. Potential lens spatters illustration

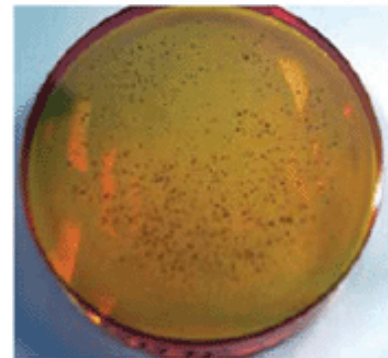
**B. Lower side (CC/ Plano)** - this type of failure is usually caused by the following reasons (see fig.2):

- Incorrect piercing pressure (too low), especially when cutting with nitrogen
- Piercing too close to the surface of the plate
- Lens not in focus / inadequate cutting speed
- Metal sheet quality - mainly rust
- Low assist gas pressure
- Thermal lensing caused by material stress, scratches on the lens surface, metal spatters etc.

Fig. 2. Spatters on the bottom of the lens

Metal spatters diffuse the laser beam, causing poor cutting quality and reduced lens life time.

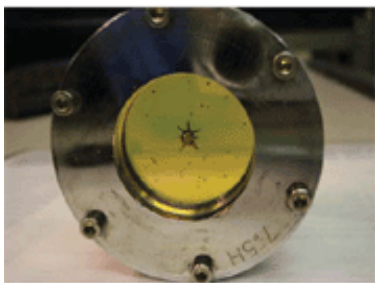
Uneven heat distribution of a focusing optic will frequently cause a star shaped fracture (see fig. 3).

Common causes of uneven heat distribution include:

- Laser beam interaction with metal spatters
- Uneven beam shape
- Inadequate lens cooling

Fig. 3. Star shaped cracks caused by uneven heat distribution of a focusing optics

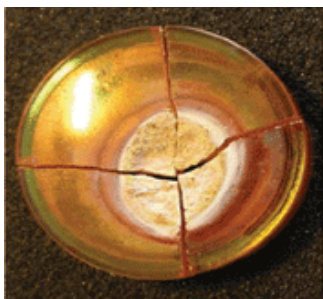
In this case, we see a massive crack occurring across the entire lens, followed by an uncentered burn mark covering the lower left area of the CX side of the lens (see fig. 4).

This type of burn is common in a Beam Mode failure; the distorted mode can generate a massive amount of energy, concentrated onto a small spot on the lens, leading to a lens explosion.

In most cases, incorrect beam mode occurs because of mirror misalignment, or failure in the beam delivery cooling system.

Fig. 4. Massive lens cracks, burn marks due to Beam Mode failure

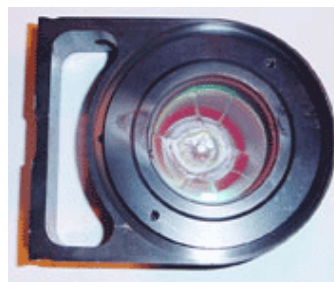
- Beam not parallel through one or more axes, striking the lens holder
- Beam mark not centered
- Failure occurs rapidly

Fig. 5. Lens cracks due to beam alignment failure

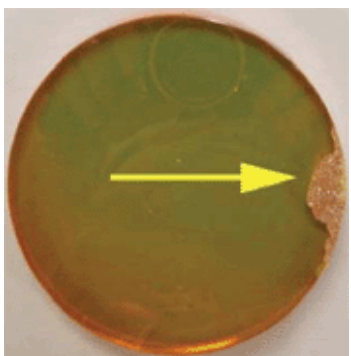
A defective lens mount will generally place a great deal of stress on the edge of an optic (see fig. 7). These stresses will be visible in the form of chipped edges or scratches along the perimeter. Common causes of mount defects include:

- Metal burrs on machined surfaces
- Contamination (metal particles) in the mount
- Indium wire not properly seated

Fig. 7. Lens edge chipped due to a stress caused by a defective lens mount

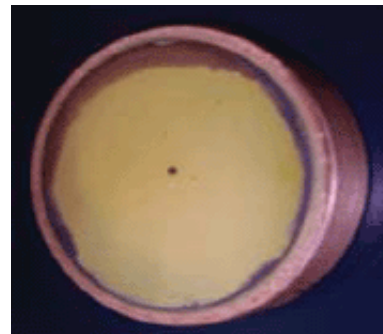
Black discoloration proceeding towards the center may indicate a water leakage from the mirror mount, evaporating coolant in the beam path, or moisture in beam purge (see fig. 8).

Fig. 8. Mirror with black discoloration

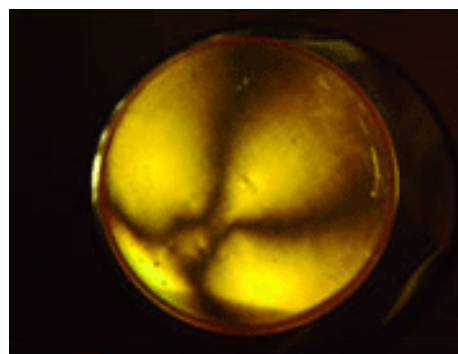
Probable causes (see fig. 9):

- Improper cleaning (may have residue)
- Wrong or poor quality cleaning supplies
- Overly aggressive cleaning (also causes scratches)
- Poor quality lens

Fig. 9. Loss of lens coating
